DEVELOPMENT OF AN ASSESSMENT METHOD FOR SEISMIC DAMAGE TO GRAVITY WASTE WATER PIPES

Master of Engineering in Civil Engineering

University of Canterbury

Yifei Tang

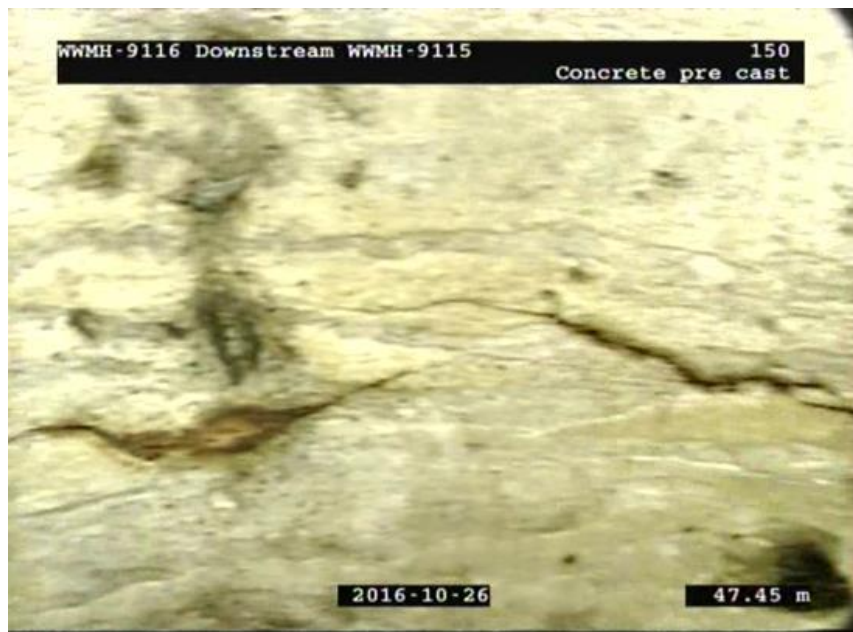
Figure 2-17. Tension cracks occurring at the top wall of the pipe only, indicating bending actions due to subsidence of adjacent pipe segments (this study).

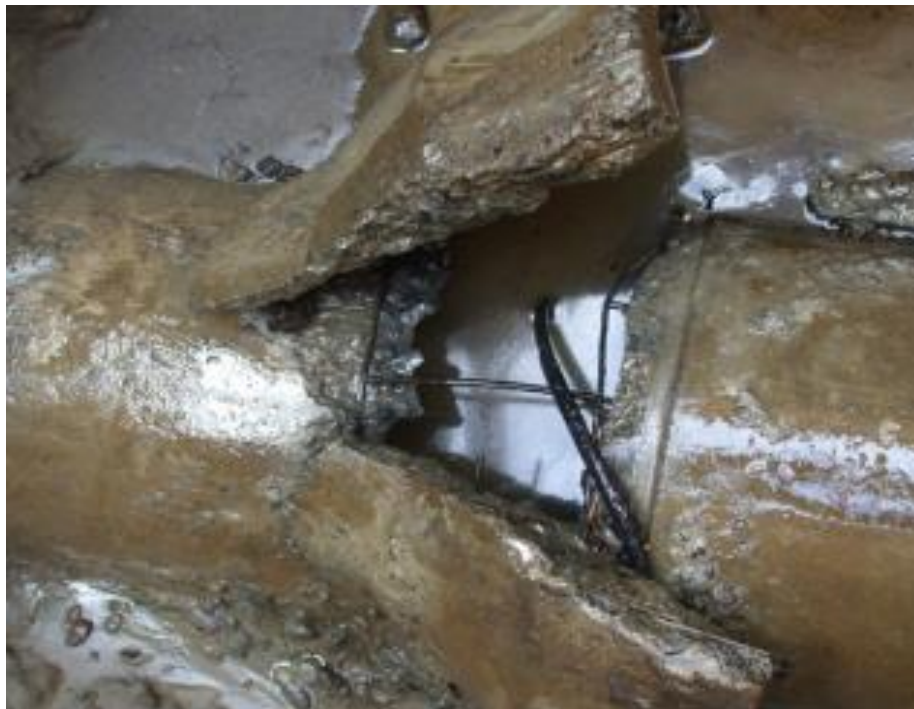
Figure 2-18. Compression forces acting on a joint causing rupture (Edkins et al., 2016)

or the thrusting of the spigot of one pipe into the collar of the neighbouring segment, resulting in spalling damage. The joint failures are due to axial forces which occur when the soil strata changes characteristics, and where the earthquake forces propagating through the soils encounter a local change of density and therefore in acceleration.

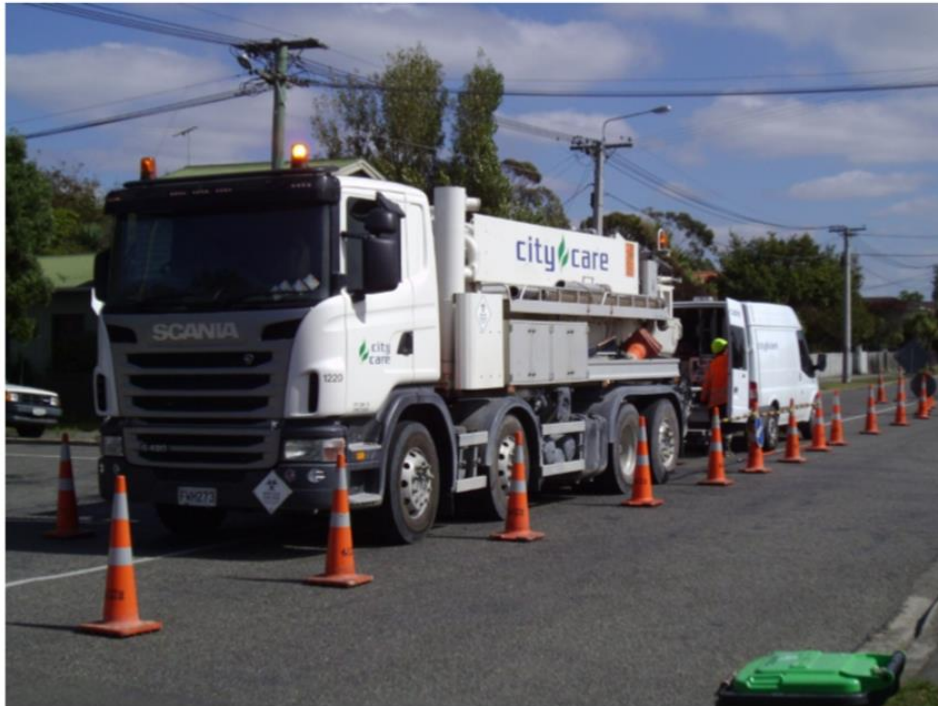
Figure 2-20. Typical example of CCTV operation showing jetting/suction truck with CCTV van, retrieved from “Asset Assessment using GIS and InfoNet” by Heiler et al. (2012)

The IRTSG required the use of the New Zealand Pipe Inspection Manual (NZPIM) for assessment of gravity waste water pipes (Heiler et al., 2012). This manual covered the inspection of pipelines exclusively using CCTV surveys. The process involves inserting a camera mounted rover into a pipe from an access manhole and capturing and transferring video recordings to an operator with a screen at the ground surface. A jetting/suction truck was often required to clean the pipe of debris and silt infiltration, as shown in Figure 2-20.

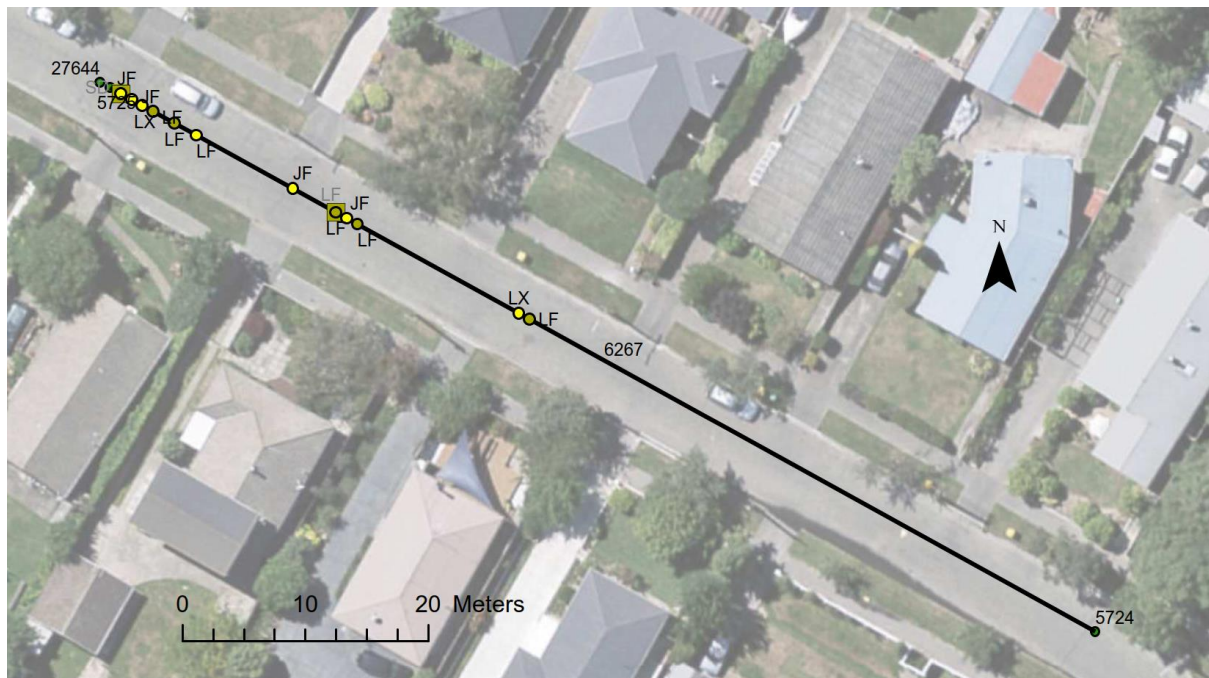
Figure 3-4. Typical pipe (Pipe ID 6267 shown) with damage observations mapped along the length of the pipe. World imagery map layer retrieved from Esri (2018). See Table 3-2 for explanation of damage codes.

Figure 3-4 shows an example pipe (ID 6267) with the pre- and post-CES damage observations colour-coded, labelled with NZPIM damage codes and distributed spatially along the length of the pipe between the manholes.

In order to distinguish between the pre- and post-CES observations, the pre-CES footage was plotted as squares while the post-CES footage was plotted as circles. The circles were chosen to be slightly smaller (size 5) than the squares (size 12) in order to allow both sets of observations to be visible when overlaid. Damage codes were also plotted adjacent to the location along the pipe for identification. The severity-based colour coding in Table 3-2 was adopted in the GIS software.

When more than one damage item existed at a single location, the damage item with the highest severity rating was plotted as only one item was visible at a time. This occurred frequently for certain damage codes such as IP (Infiltration Present) or ED (Encrustation Deposit), which are always accompanied by crack codes or joint damage codes due to the nature of the damage itself, as these items indicate complete penetrations in the pipe walls allowing external water to enter and cause gushing (IP) or rusting (ED).
